## **IXARO Paging Systems**

Location of hardware failures

Version 4/2014

# Location of hardware failures in IXARO Paging Systems

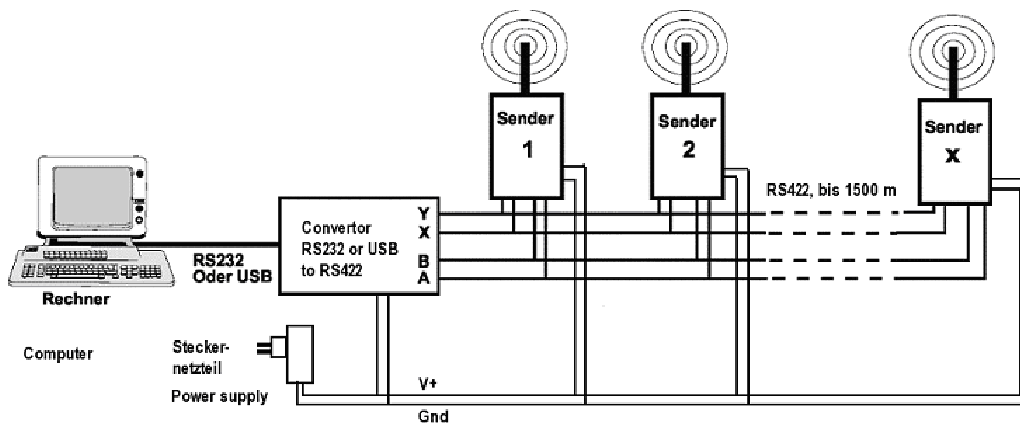
Fig. 1 Typical configuration of an IXARO BUS System. The converter is either an EX9520 or EX9530 from the manufacturer TOPSCCC.

To cover wider areas than possible with a single transmitter the IXARO Paging system was upgraded to operate with several transmitters each covering a certain area. To simplify wiring of extended installations the interfacing between computer and transmitters is accomplished by a RS422 based bus system. This allows cable lengths up to 1500 meters and operation of up to eight transmitters on one cable. This cables provides also power supply.

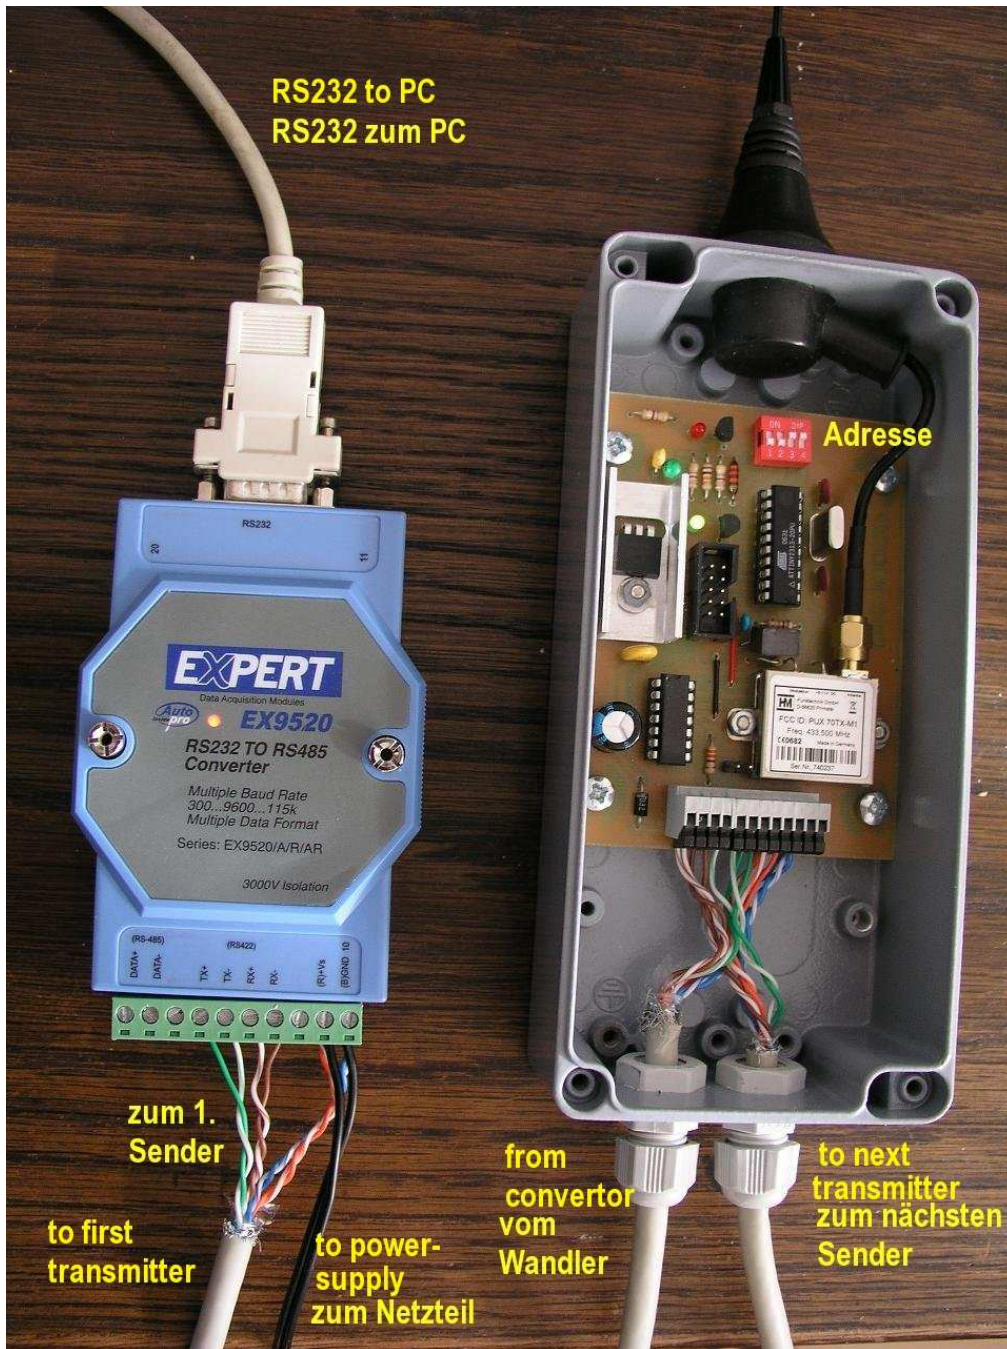
Fig.2 Photo of the wiring between convertor and transmitter. A serial/RS422 convertor EX9520 is used here. The transmitter as well as the convertor need a power supply. If the EX9530 is used the power supply MUST NOT be connected to the convertor otherwise it will be damaged. The EX9530 is USB powered.

EX9520(RS232)	EX9530 (USB)	Transmitter	Colour of leads	Function
TX+	TX+	A	Green	Data line
TX-	TX-	B	Green/White	Data line
RX+	RX+	Y	Brown/White	Data line
RX-	RX-	Z	Brown	Data line
+Vs	No connection	V+	Orange+Orange/White	Power +
Gnd	No connection	Gnd	Blue+Blue/White	Power Gnd

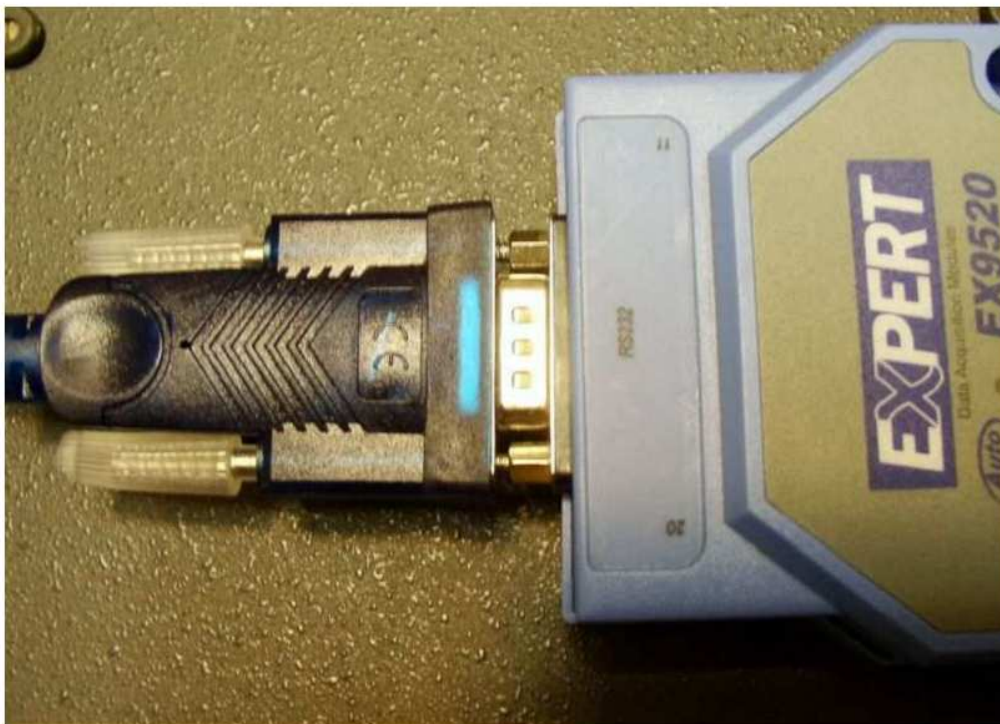
Fig. 3 Combination of EX9520 and serial/USB-converter which has been plugged into the RS232 socket of the EX9520. The RS232/USB converter is contained within the plug.

There are two types of convertors in use. The older one, type EX9520, is an RS232 to RS422 convertor. The EX9520 needs to be connected to a 12 Volts power supply. Since serial ports are no longer usual on PC's the EX9520 convertors have been combined with RS232 to USB convertors to use them like USB convertors.

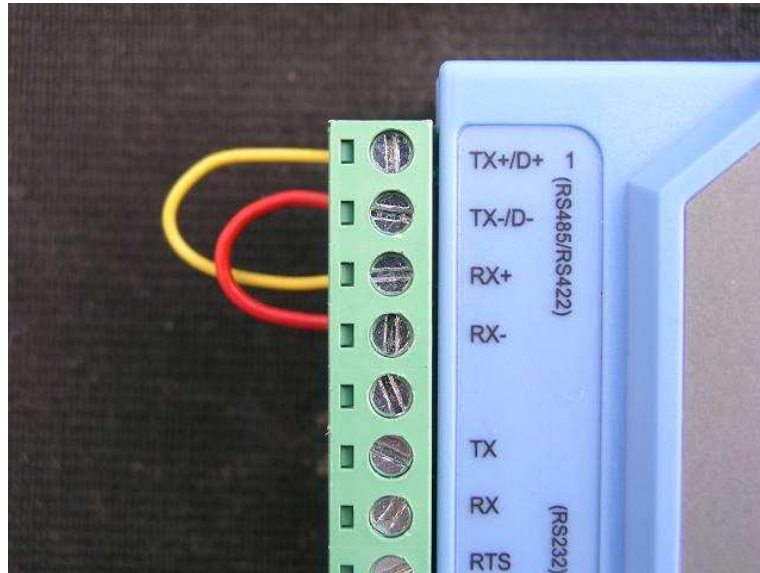
Fig. 6 Bridge wires for the loopback test on the EX9530

Please remove all data lines to the transmitter from the converters output. You will need two short pieces of wire with stripped ends. Use one wire to bridge Terminals TX+ and RX+ at the converters clamps and the other one to bridge TX- with RX- (see picture 1).

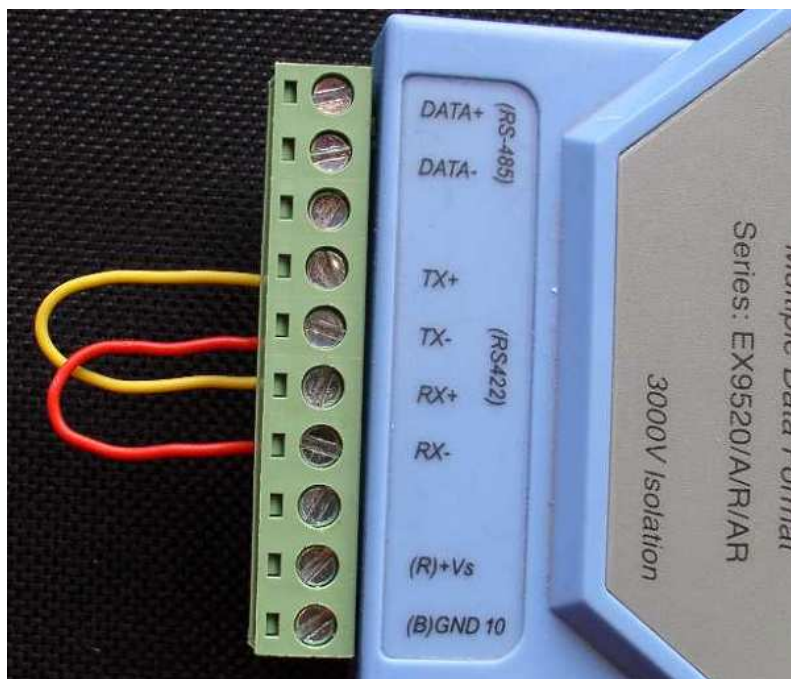
Fig. 7 Bridge wires for the loopback test on the EX9520

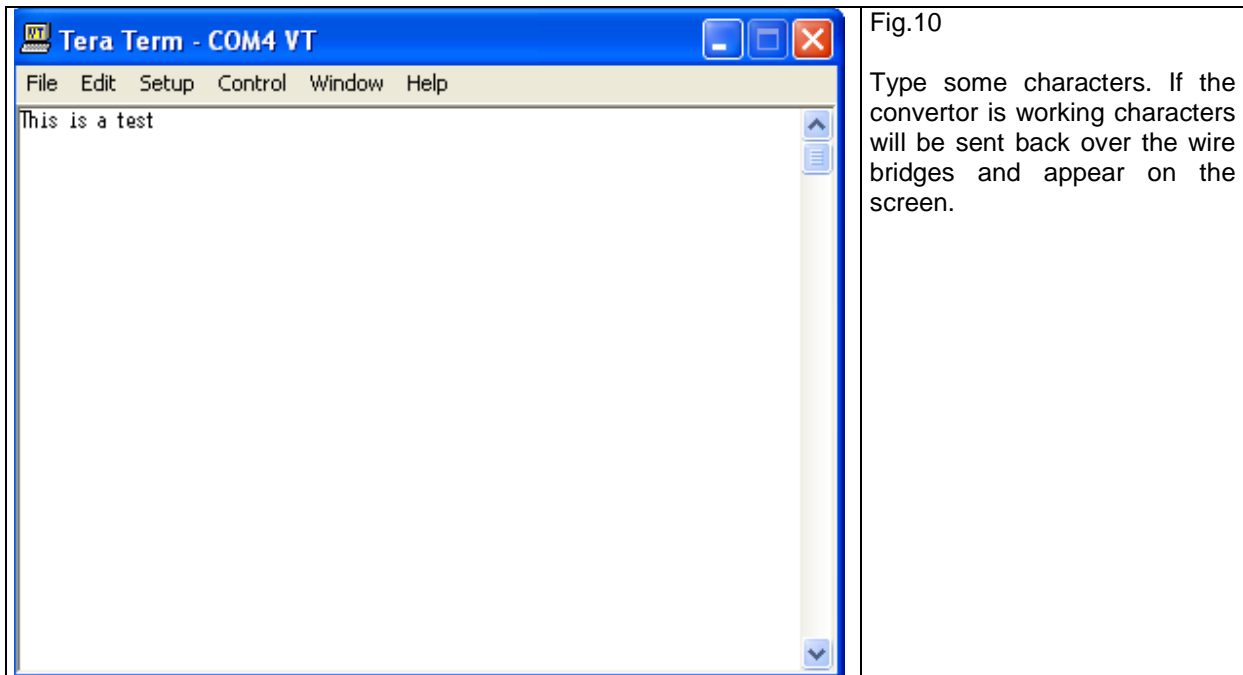
Fig.10

Type some characters. If the convertor is working characters will be sent back over the wire bridges and appear on the screen.

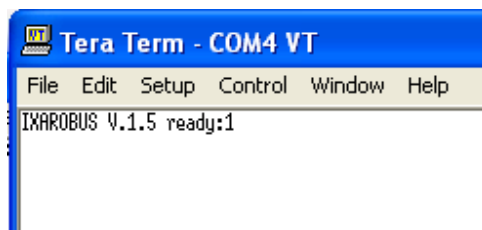
Fig.11 Response of the transmitter to the identify-command "I1"

When characters appear as you type them the cable from convertor to transmitter is in order. Therefore it is likely that the transmitter is faulty. To prove that reattach the data wires to the transmitters clamps. To check the transmitter use the Identify-command. Type I1 and the ENTER. You have to type this blind since there is no echoe from the transmitter. The transmitter will respond with "IXAROBUS V.1.5 ready:1". This is the procedure to check transmitter 1. If there is a second transmitter in the system type I2 and the transmitter will respond IXAROBUS V.1.5 ready:2
